Pentium® II Xeon™ Processor Specification Update

Release Date: October 1998

Order Number: 243776-006

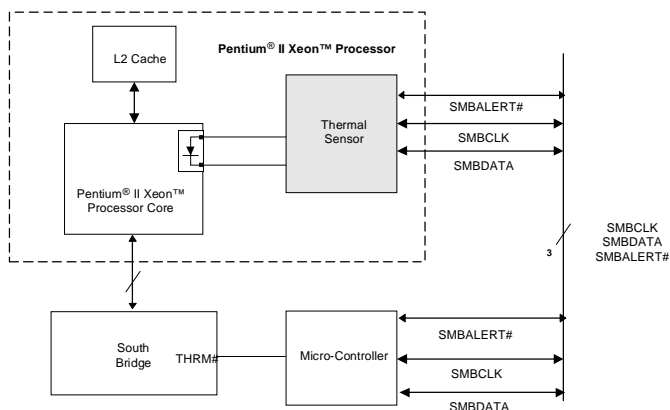
Figure 1. An Example of Micro-controller Driven Thermal Management

D30. Thermal Sensor May Assert SMBALERT# Incorrectly

PROBLEM: The Pentium II Xeon processor has a thermal sensor that monitors the processor core's temperature. The thermal sensor asserts SMBALERT# if the processor temperature exceeds the temperature limits set in the Alarm Threshold Registers (T_{HIGH}, T_{LOW}). It also sets the corresponding Status Register bits to identify the cause of the interrupt. Figure 1 gives one example of the how the SMBALERT# signal could be used in a system.

Under the conditions described below, the thermal sensor incorrectly generates the SMBALERT# interrupt. *All* of the following conditions must be met to trigger a false interrupt:

WORKAROUND: Three different (mutually exclusive) workarounds are possible:

1. Before servicing an interrupt from the thermal sensor, read and compare the processor thermal reading with the threshold limits (T_{HIGH} or T_{LOW}). Figures 2 and 3 provide basic flowcharts for the implementation of this workaround in an interrupt driven system.
2. If the firmware implemented polls the Status Register only, then before taking any action, re-read the temperature register and do a comparison with the alarm threshold limits (T_{HIGH} or T_{LOW}) to determine if the value is actually still within the temperature window.
3. Use a temperature polling scheme to monitor the processor temperature.
